# Community Asset is Restored

Ranger Lake, which now averages one foot deep or less, sets in the shadows of the new Dallas Cowboys Stadium.

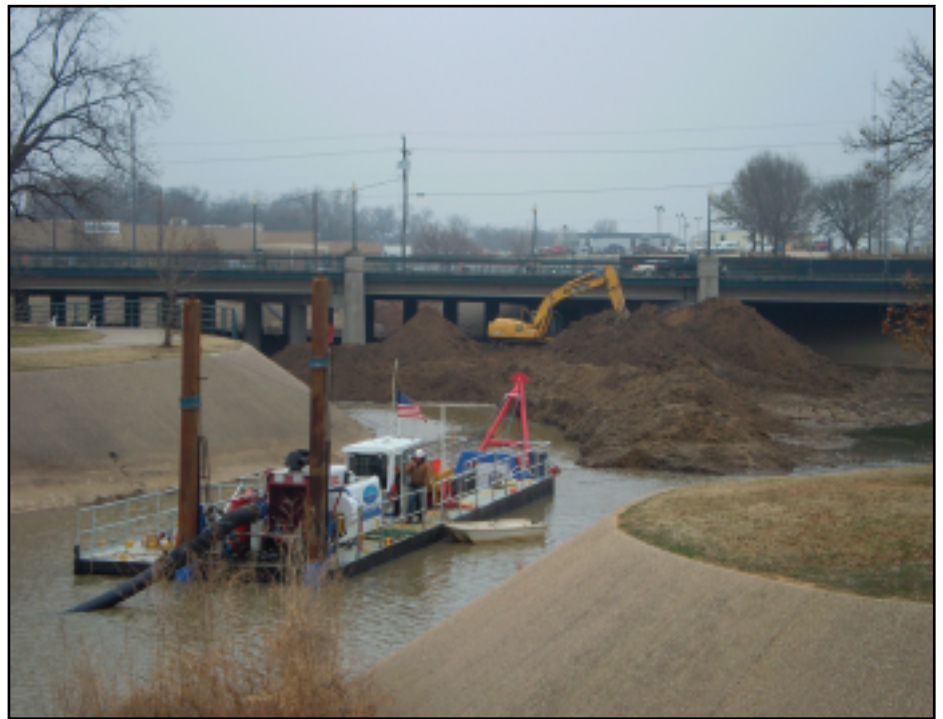
The dredge "Liberty" moves up the creek to remove a large stockpile of material that was pushed "down the creek" with dozers.

This apron did not allow enough clearance for the dredge to float up the creek. The dredge needed to get past this bottleneck in order to reach the area upstream where a large amount of built up sediment had to be removed. The dredge drafts 28" and the depth of water at this location was only 24". This problem was solved by temporarily putting

sandbags on top of the overflow dam and raising the level of the lake enough to clear the apron. After this, it was clear

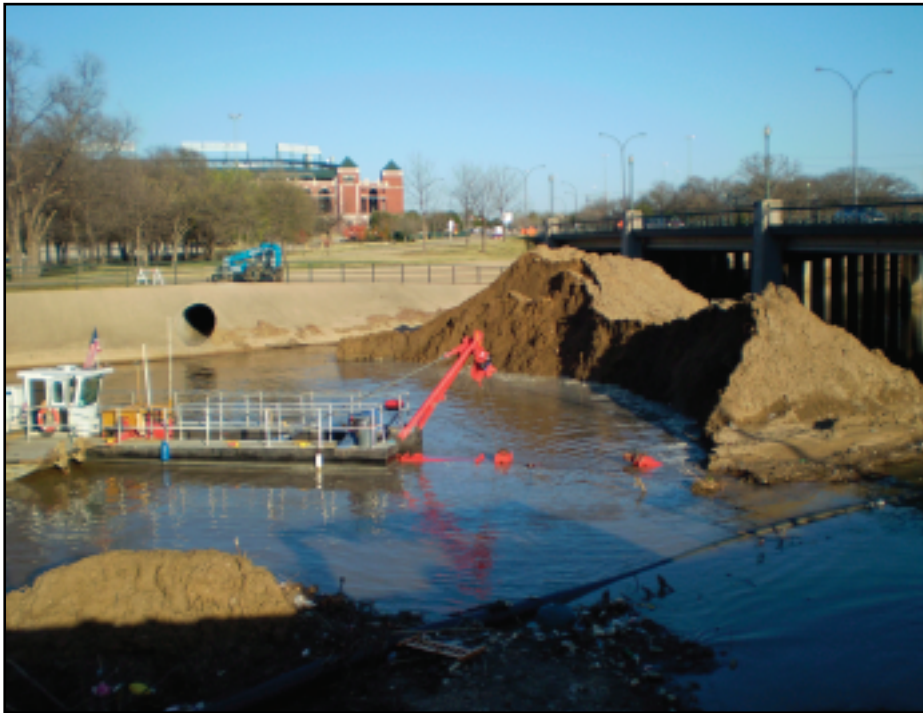
With Ranger Stadium in the background, the dredge chips away at the stockpiled material in the creek and pumps it 1.5 miles to a settling basin.

The contractor mobilized their hydraulic dredge and constructed a temporary 1.5 mile pipeline to pump 110,000 cubic yards of sediment to settling basins constructed upstream. The sediment settled in the basins and the clean water flowed over a flashboard riser where it returned to the lake. A booster pump was utilized in line to ensure the heavy sand was carried the distance.
